Inspecting Your Adventure Playground

**Guidance for playworkers who are
carrying out routine visual and operational
inspections on their playground(s)**

A N Other Borough Council
Report of an Annual Inspection
Example Adventure Playground

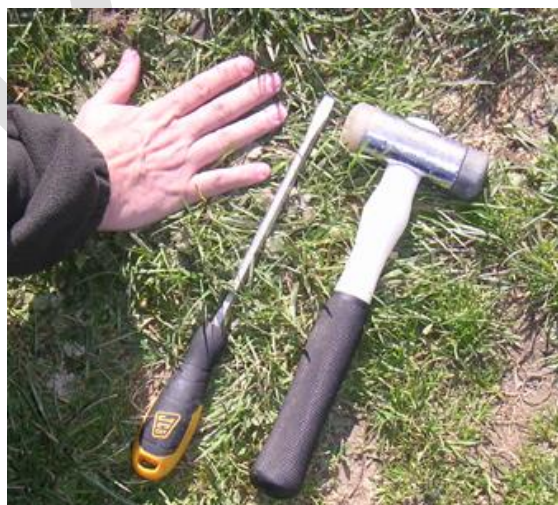
The second a flat head screwdriver which is available from a variety of manufacturers. It is the most common size for a good stout screwdriver. These normally have a blade length of 200mm.

Tools used at inspections

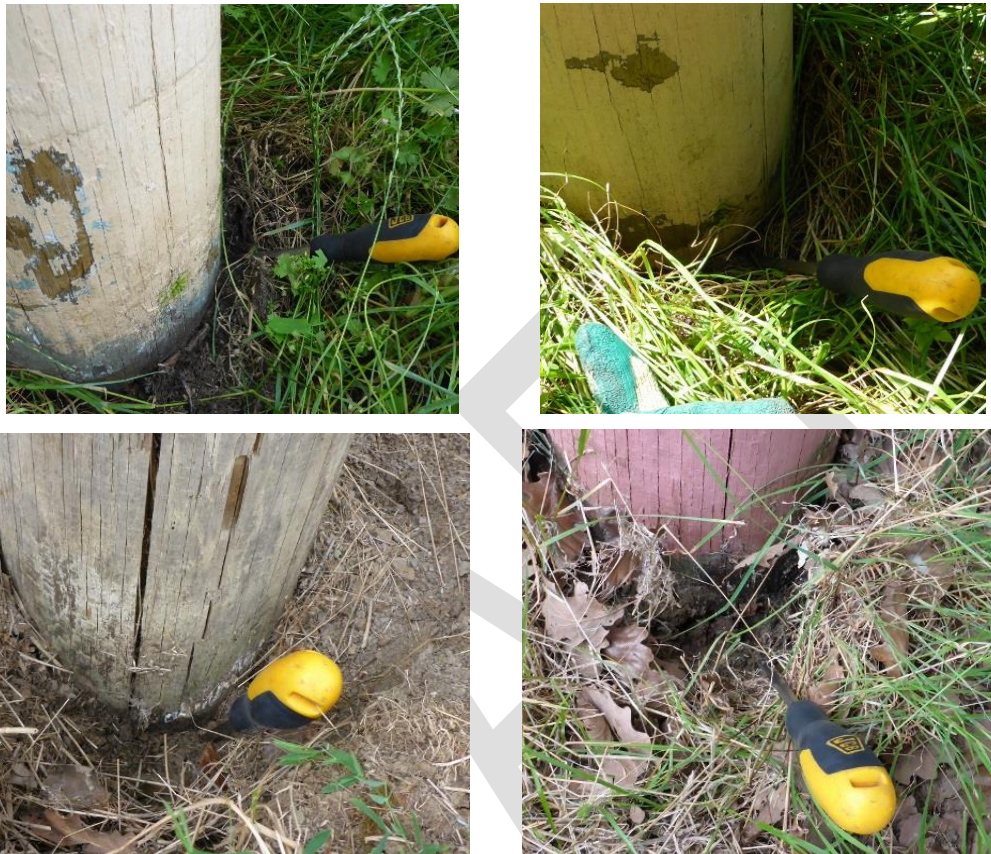
Supports tend to rot/rust just below ground level. The screwdriver should be pushed in 2-4 inches below the surface. Because it's a flat-head it should only cause damage if the support is already deteriorating.

Inspecting for rot with a screwdriver

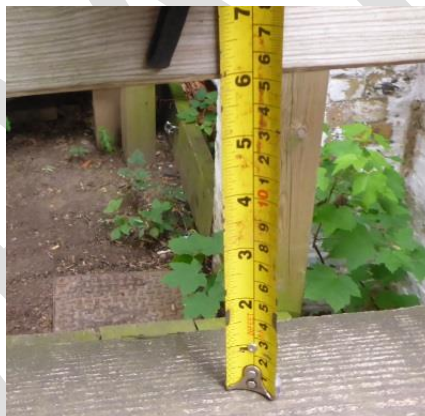
Gaps between steps give head entrapment potential – *Infill to reduce to max. 89mm – Low/Medium Risk (does not apply when distance to deck is less than 600mm).*

Gaps between barrier uprights exceeds 89mm. As they are at 100mm the risk is acceptable.

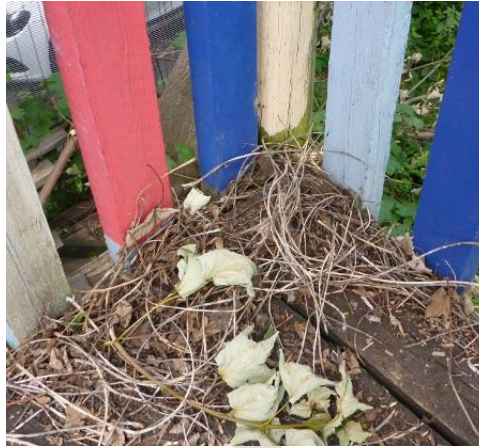
4 missing uprights and missing section between climb wall and ramp – *Replace planks – Low/Medium Risk*

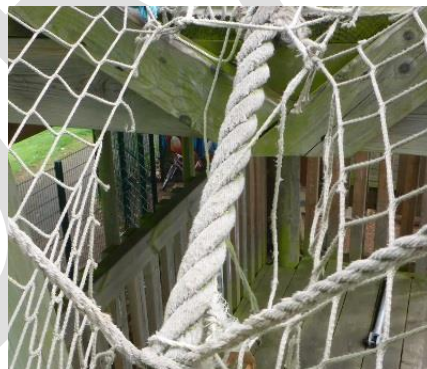
Fall arrest net holed at near end – *Repair – Medium Risk* (Ropes have been fixed to indicate that the bridge is out of use. It is, however, easy to get past these ropes and the bridge is an obvious inducement for children, therefore the net should be repaired with some urgency.)

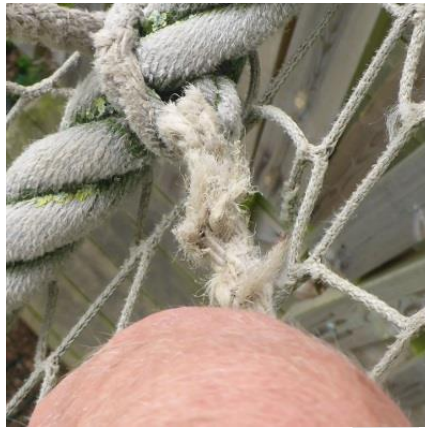
Vertical rope at far end is breaking/fraying – *Replace – Low/Medium Risk*

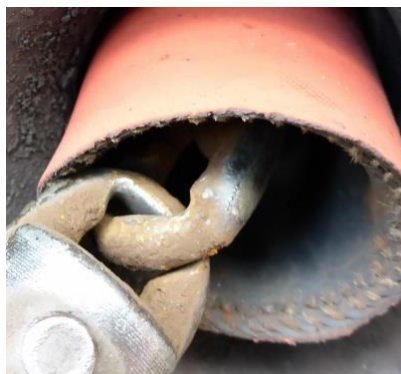
CONDITION: Worn bottom links (hidden inside seats) – *Replace – Medium Risk*

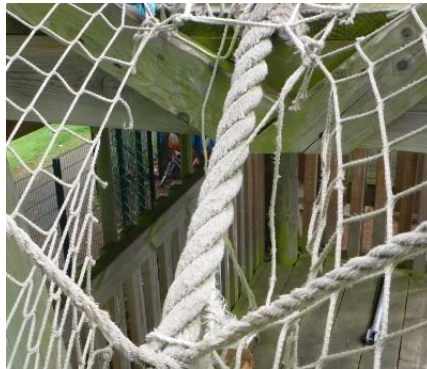
Fall arrest net holed at near end – *Repair – Medium Risk* (Ropes have been fixed to indicate that the bridge it is out of use. It is, however, easy to get past these ropes and the bridge is an obvious inducement for children, therefore the net should be repaired with some urgency.)

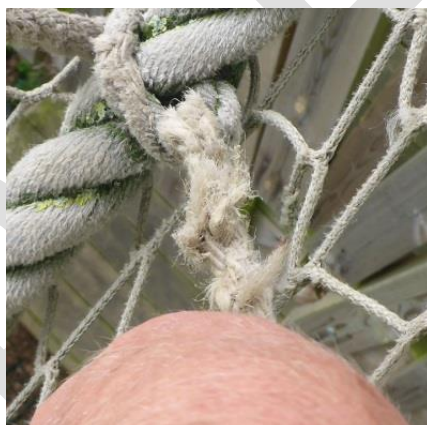
Vertical rope at far end is breaking/fraying – *Replace – Low/Medium Risk*

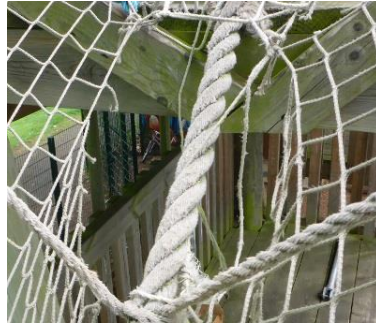
Fall-arrest net holed at near end — *Repair* — *Medium Risk* (Ropes have been fixed to indicate that the bridge is out of use. It is, however, easy to get past these ropes and the bridge is an obvious inducement for children, therefore the net should be repaired with some urgency.)

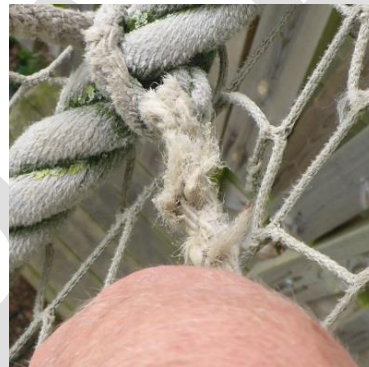
Vertical rope at far end is breaking/fraying — *Replace* — *Low/Medium Risk* *still needs doing*

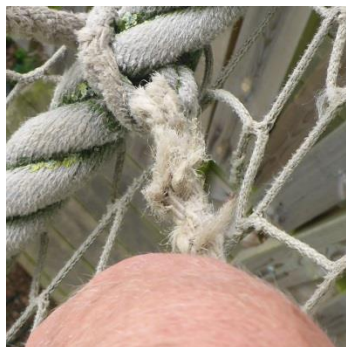
Vertical rope at far end is breaking/fraying – *Replace – Low/Medium Risk still needs doing*
